September 1, 1989

Re: Summary Letter Report regarding the
Fuel Oil Contamination Problem at the
Silver Residence, No. Bennington, VT.

Figure 2
Silver's Residence - North Bennington

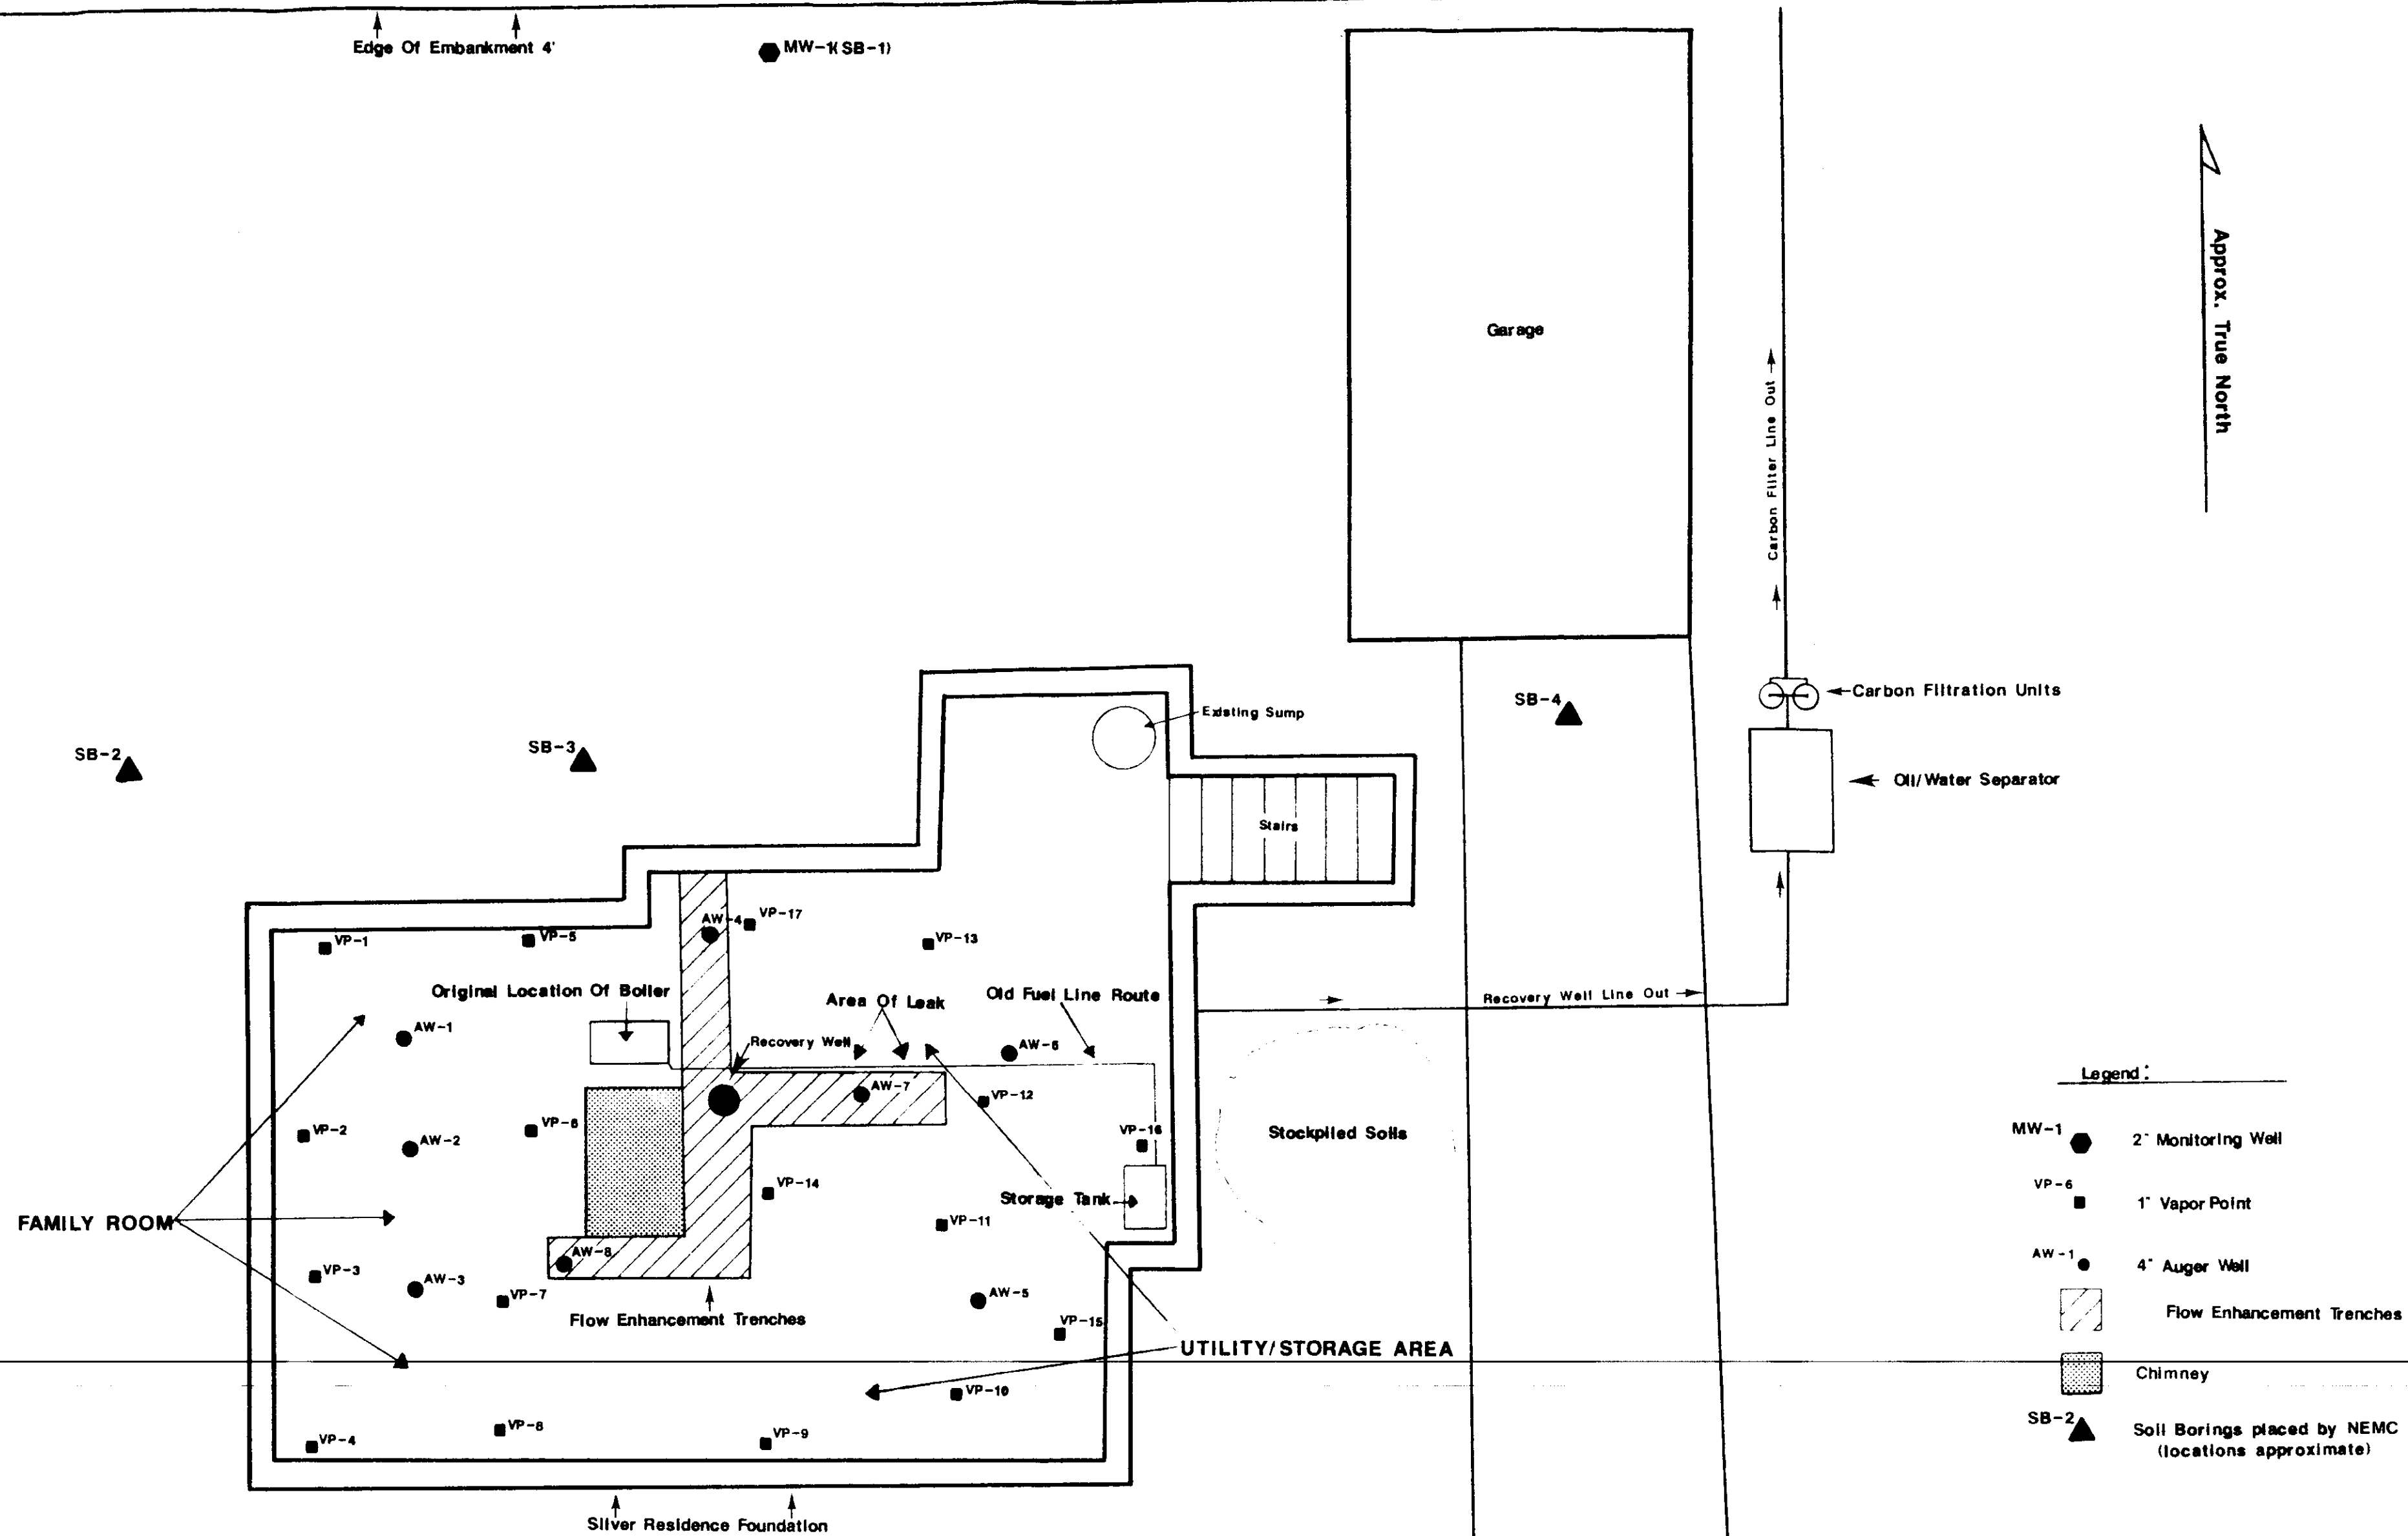
Based upon the appearance of the soils within the observation trenches, it became apparent to LAG that fuel oil contamination most probably existed beneath the majority of the basement area. In an attempt to directly impact the most severely affected areas of the basement, the observation trenches were excavated to a depth where native soils were encountered. The soils encountered during the excavation of the observation trenches consisted of approximately 1.5 feet of stony, silty fill. The fill soils thickened to 2.5 to 3 feet in the areas of the chimney and the footing of the north wall. The fill soils near the chimney contained large amounts of free phase fuel oil. The soils associated with the far ends of the original trench contained fuel oil vapors only. The fill soils associated with the new trench contained free phase fuel oil adjacent to the chimney and the north wall footer. The native soils below the fill resemble a lake bottom or wetland clay that naturally confines the fuel oil to the basement yet has been unaffected by the spill. The native clay representing a natural barrier was sloped from the far ends of the trenches towards the recovery well and filled with approximately 1 to 2 feet of 1" diameter crushed stone. The placement of the stone created preferred high permeability paths for the ground water and fuel oil to flow beneath the basement floor. The stone filled trenches (now referred to as flow enhancement trenches) were sealed with polyethylene plastic to reduce vapors. As the flow enhancement trenches were excavated, the contaminated soil was removed from the basement and stockpiled on and covered by plastic adjacent to the residence. The location of the contaminated soils and the finished flow enhancement trenches are located and shown on Figure 2.

Five hand augered monitoring wells were installed through the basement's concrete floor. These wells are labeled AW-1, AW-2, AW-3, AW-5, and AW-6 and are shown on Figure 2. Each of these wells was augered to a point at least 1 foot into the native clay layer. A 4-inch diameter filter fabric wrapped, axially slotted monitoring well was installed in each auger hole. Each of the wells was sealed at the floor surface with a water tight cement to prevent vertical movement of contaminated ground water, vapor, and free phase fuel oil into the basement living space. Three additional 4-inch monitoring points were installed in the flow enhancement trenches. Each of the wells, labeled AW-4, AW-7, and AW-8, were placed in the trenches at a point farthest away from the recovery well. These wells are also shown on Figure 2.

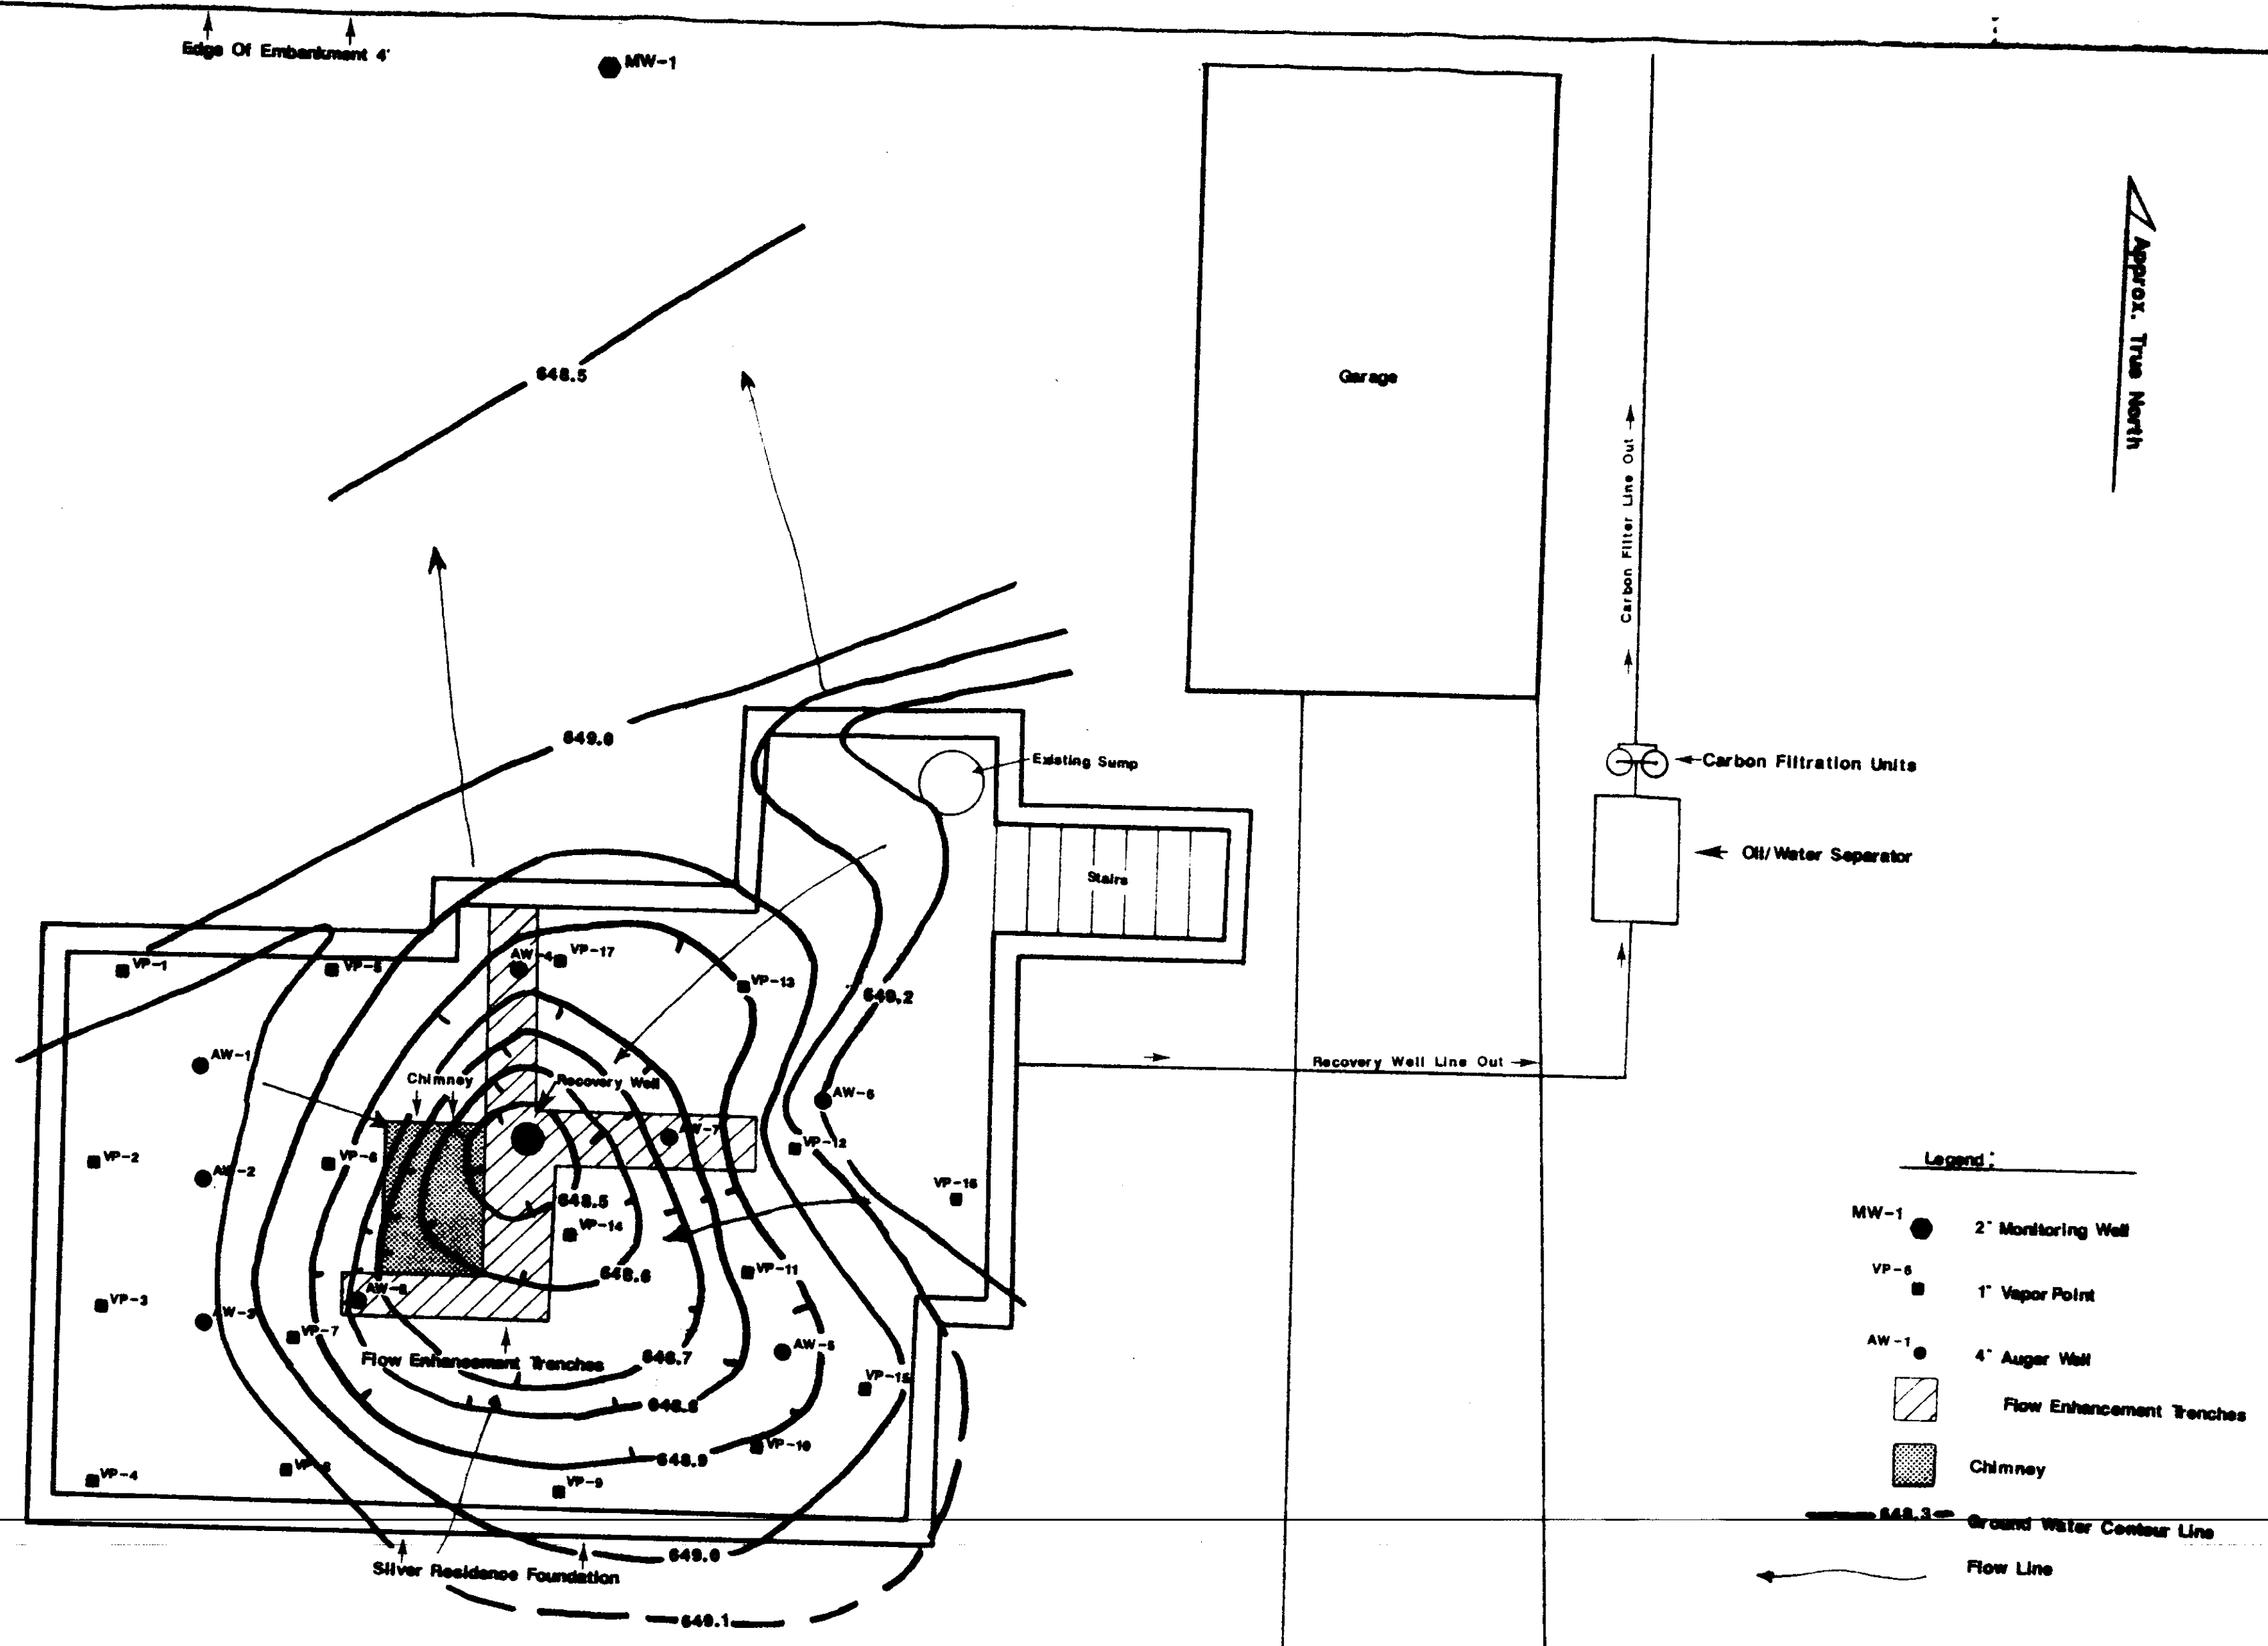
Figure 3

directions and flow gradients. The contour maps for data collected on July 11, July 28, and August 18, 1989 are enclosed as Figures 3 through 5 respectively. As can be seen on each of these figures, a substantial cone of depression exists in the ground water system beneath the basement floor. This cone of depression has been created by the ground water depression activities occurring in the recovery well. Normally, the ground water flow direction through the site is from south to north at a relatively steep gradient of approximately 0.042 feet per foot. Figures 3 through 5 vividly show that ground water within the basement area slopes towards the recovery well. The water and product monitoring data presented as Table 1 shows that product thickness in the basement area has decreased to a point where no free phase fuel oil is evident. The ground water elevation/product thickness data presented on Table 1 is also enclosed in graphical form as Figures 6a through 6j. Each of these graphs show how ground water elevations across the site have been steadily increasing, while product thicknesses have been steadily decreasing.

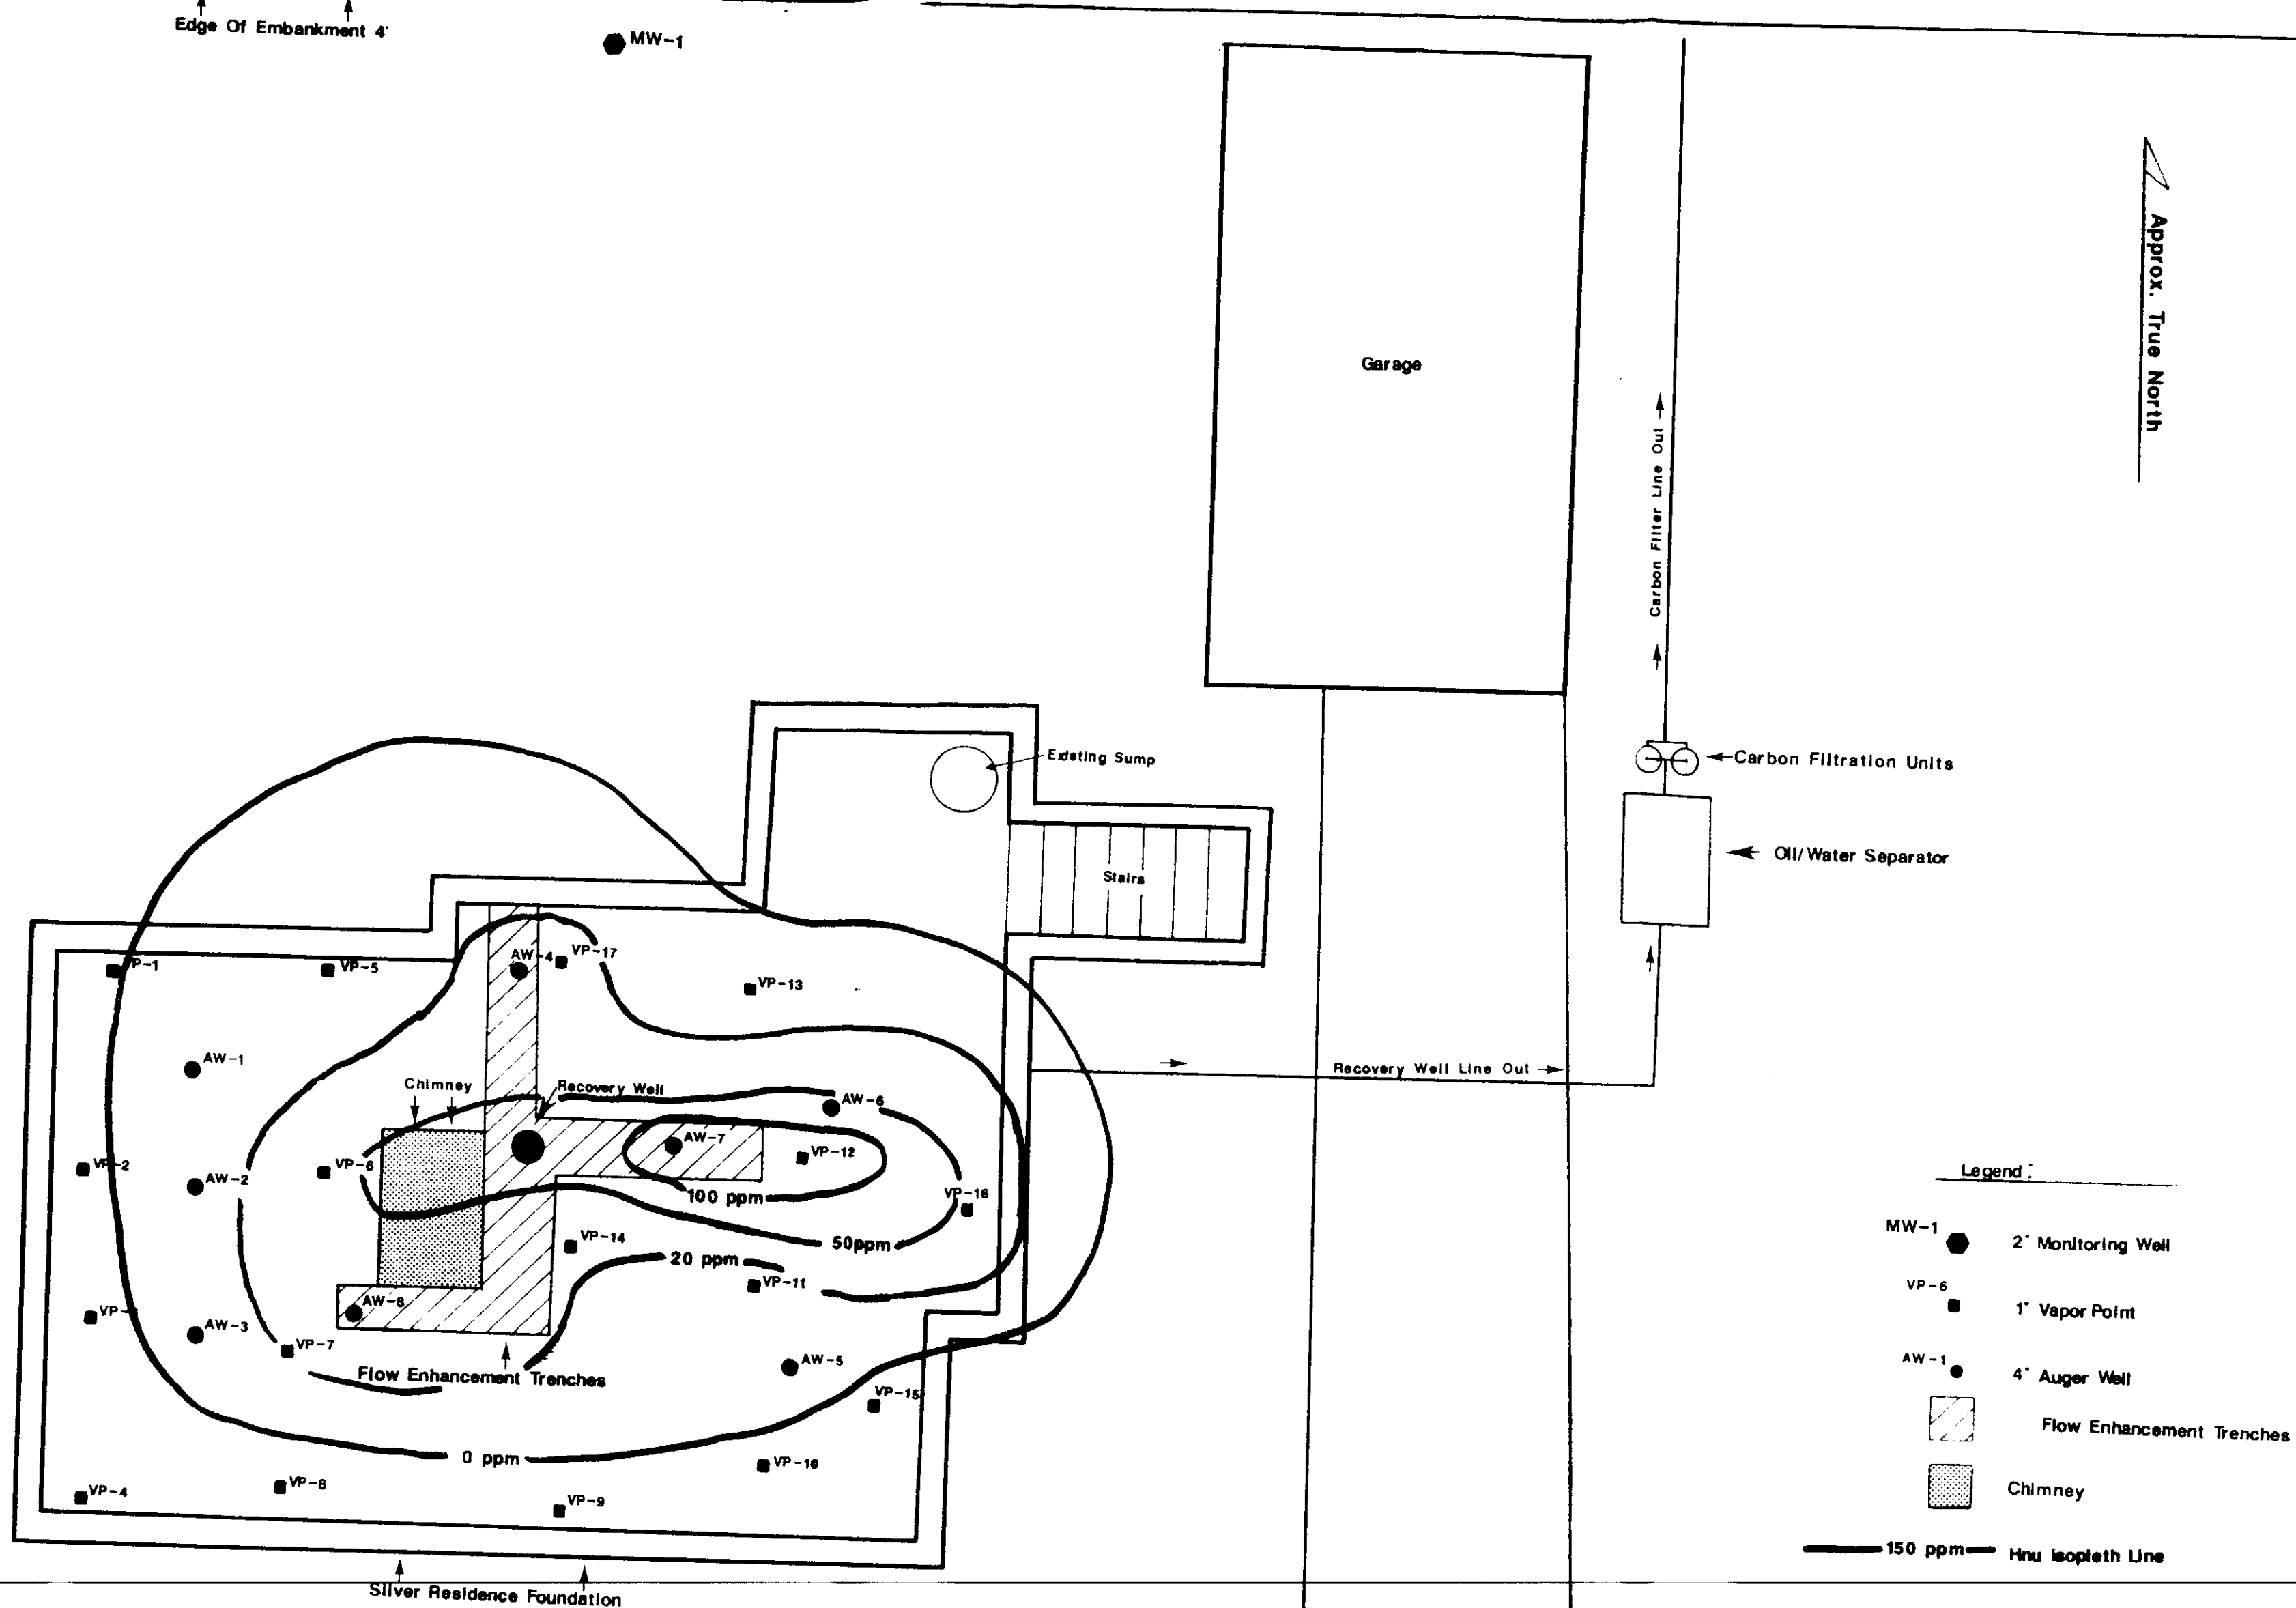
Figure 7a	
Silver's Residence - North Bennington	
Scale: 1" = 5'	Date: 7/89
HNH ISOPLETH MAP (ppm) for 7-11-89	
Drawn By: PDT	Problem: Fuel Oil Contamination

Weekly HNU data collected from the vapor points is presented as Table 2. Vapor levels have fluctuated considerably throughout the investigation period. Figures 7a through 7c represent the HNU isopleth (concentration contour) maps for July 11, July 18, and August 28, 1989. Figure 7a shows the HNU data for July 11, 1989. At this time the majority of vapor was associated with the east-west running flow enhancement trench and the recovery well. Figure 7b shows how the area of vapor contamination has increased drastically in size in the areas of the northern most wall of the basement, AW-3, and AW-8. Figure 7c also shows vapor contamination increasing in these areas. Overall, the HNU concentration data indicates that the vapor plume is becoming larger and is migrating away from the source area. The presence of this vapor plume indicates that fuel oil vapors will require continuous removal (in order to make the home habitable) unless its source (the free phase fuel oil) is removed completely.
